INSPECTION OF LANDSLIP AT HAZELWOOD

DECEMBER 2013

# INSPECTION OF LANDSLIP AT HAZELWOOD

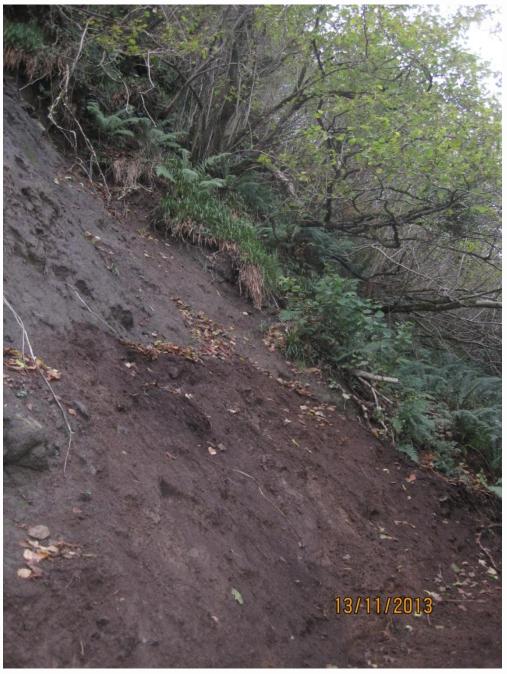
- 1.5 The area where the recent slip occurred has been cleared of debris and the path is clear and the rock face is exposed, see attached photographs nos 1-5.

2.1 The slip is not a true slip in the sense of the word rather, as described above; it is the slippage of the overburden material off the very steep rock face. The slips are occurring at various locations and at infrequent intervals and are due to the instability of the overburden material on the steep rock face of the escarpment. The rock face itself appears to be stable so the problem is with the overburden. Due to the extent of the overburden material and the heavy undergrowth it would be impractical to remove it in order to stabilise the slope above the path. The slips will, in our view, continue to occur and are more likely to occur during or after very wet periods or snowfall. These events increasing the weight of the overburden and triggering the slippage of the overburden down the rock face.

- 3.2 There are a number of options for dealing with the problem and these are:
  - 1 This section of path could be closed and the users rerouted. A rerouting of the path would need to be thoroughly investigated and assessed for safety.

- 2 A section of suitable fence could be constructed on the upper side of the path to retain slip debris. The fence would need to be sufficiently robust to retain the debris.

- 3 The minimum option would be to erect warning signs along this section of path to warn users of the potential risks associated with using this section of path.
