REPORT ON INSPECTION

FOOTBRIDGE ON ROUTE

CAVEHILL PATHWAY

JULY 2014

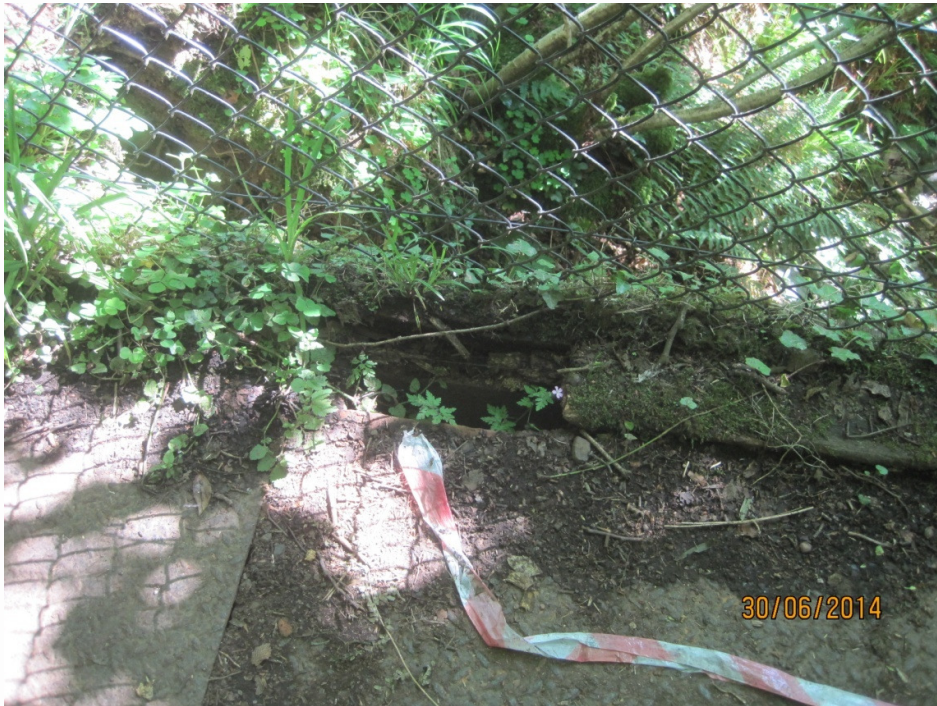
A visual inspection indicated that the bridge surface is in poor condition with parts of the surface already rotted away. See Photo No 1

Figure 1 Rotting Deck Timber

Overall we would advise that the bridge is unsafe for use and recommend that it is removed from the site. Removal will avoid unauthorised use and the attendant risks associated with such use. At present the ends of the bridge are blocked with low level barriers which we would consider as inadequate to prevent unauthorised usage. See Photos 5 and 6.

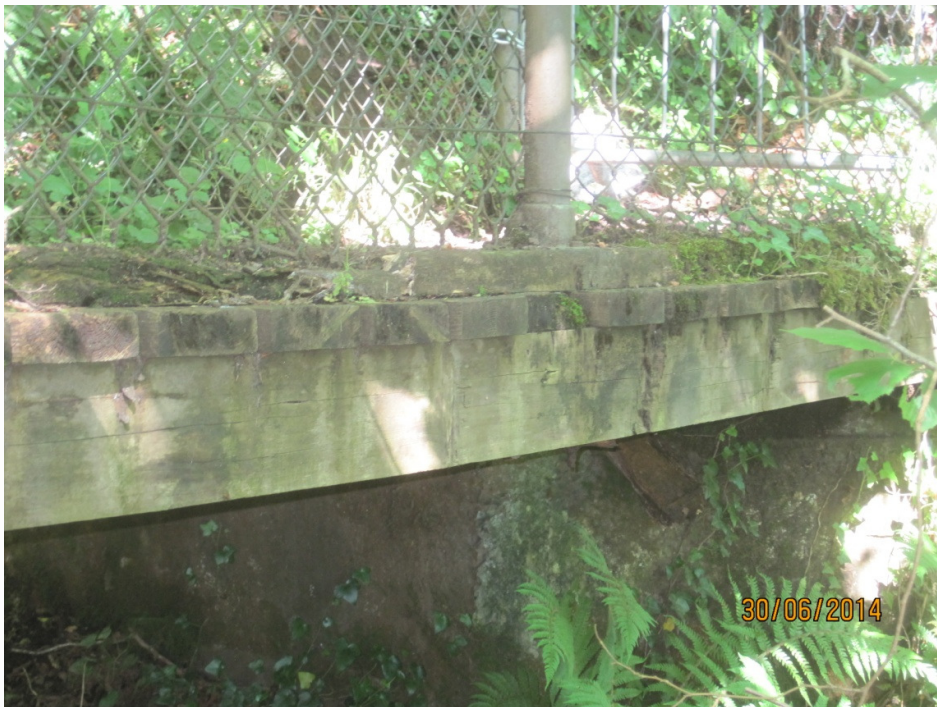
The deck support beams are in poor condition with significant sag. There are vertical cracks in the beams which would indicate that they are close to failure. These beams would also appear to be rotting in places. See photos 2, 3 and 4.

Figure 2 Bridge Beams

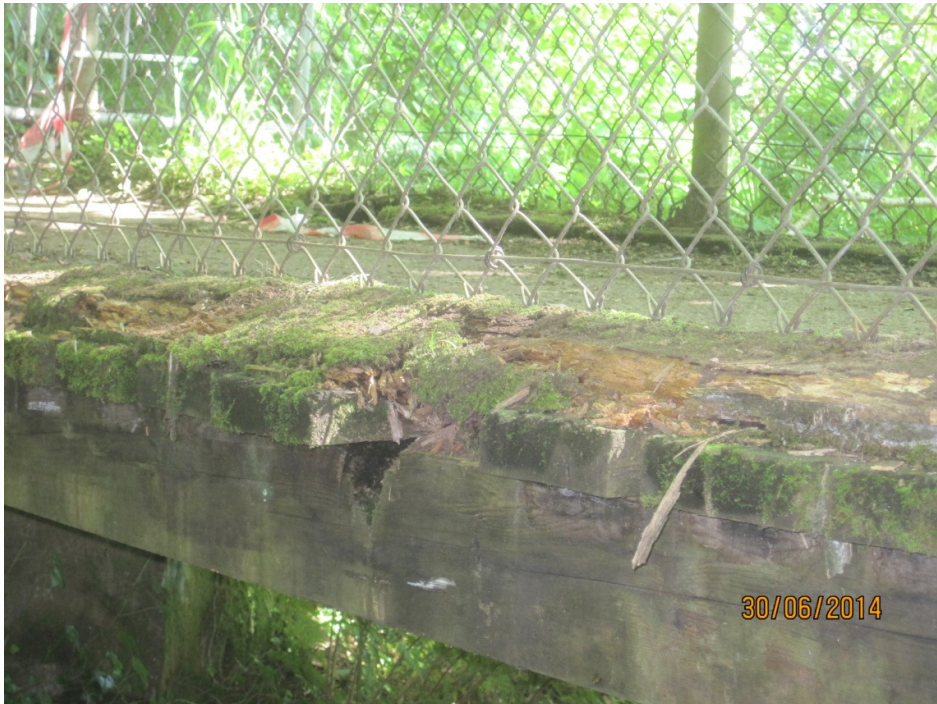
Figure 3 Bridge Beams

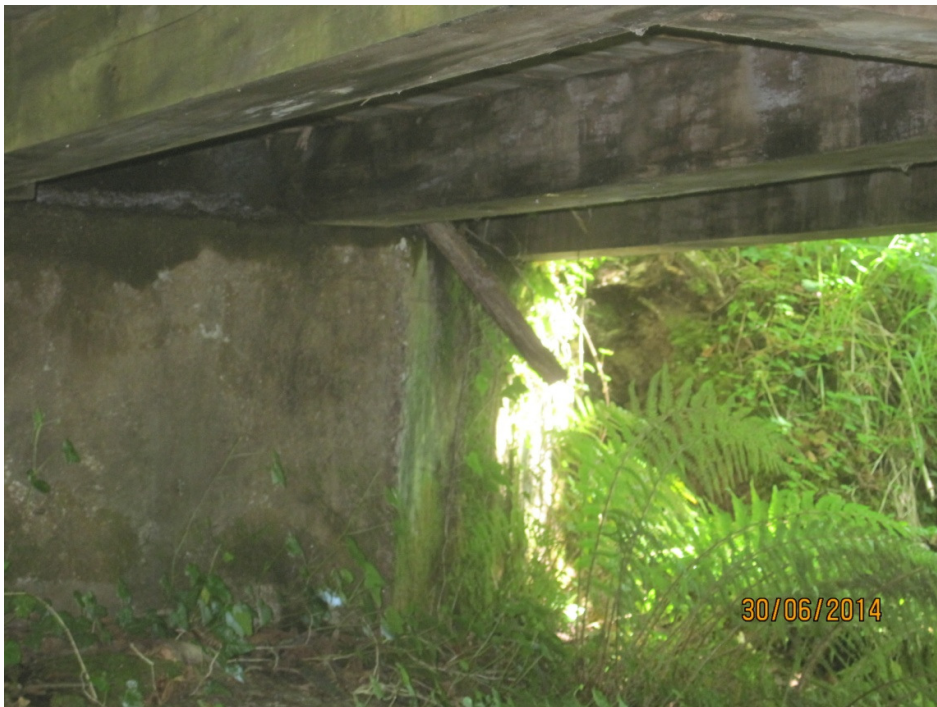
Figure 4 View of underside of bridge
