**Doran**  
**CONSULTING**  
DELIVERING ENGINEERING EXCELLENCE

INSPECTION OF LANDSLIP  
AT  
HAZELWOOD

DECEMBER 2013

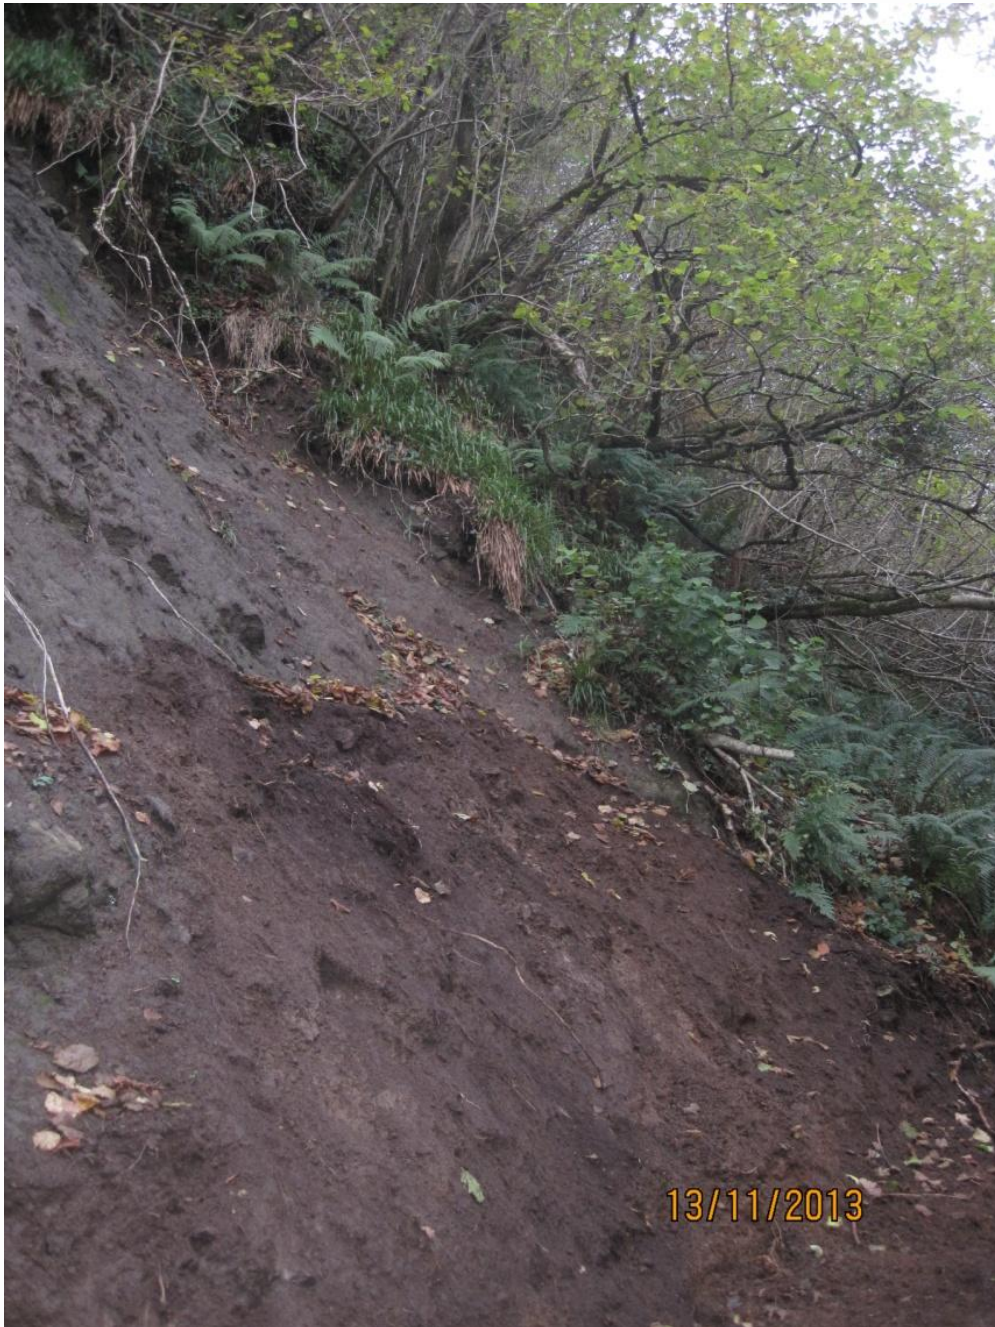
**Photograph 1**

- 1.5 The area where the recent slip occurred has been cleared of debris and the path is clear and the rock face is exposed, see attached photographs nos 1-5.
