Rookery at Victoria Park - Implications to air safety.

This short report is a rationale and review of options presented by the development of a small rookery (circa 20 nests) which became established in the northern corner of Victoria Park in spring 2020, 300 metres from the airport's southern landing approach.

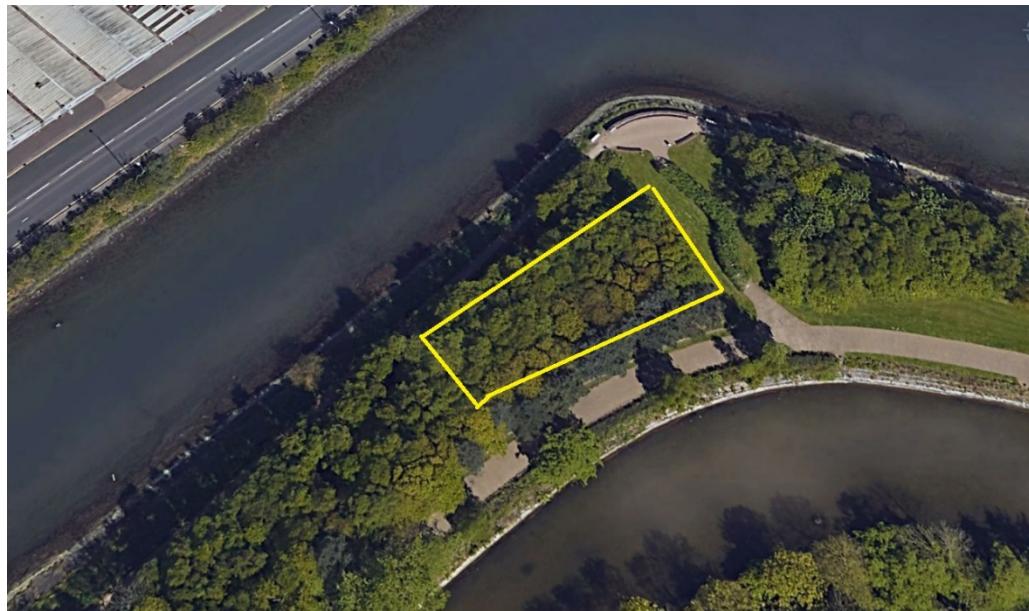
Extent of 2020 rookery at Victoria Park

Nest removal

As the rook nests are between 10 and 15m high, it is envisaged that most can be dislodged from the ground or the higher ones from ladders, using extended poles. Recording trees used and photographing nests before and after removal will inform and facilitate any structural pruning that might be feasible as a management tool. In the event of nest rebuilding the same information would be recorded prior to removal.

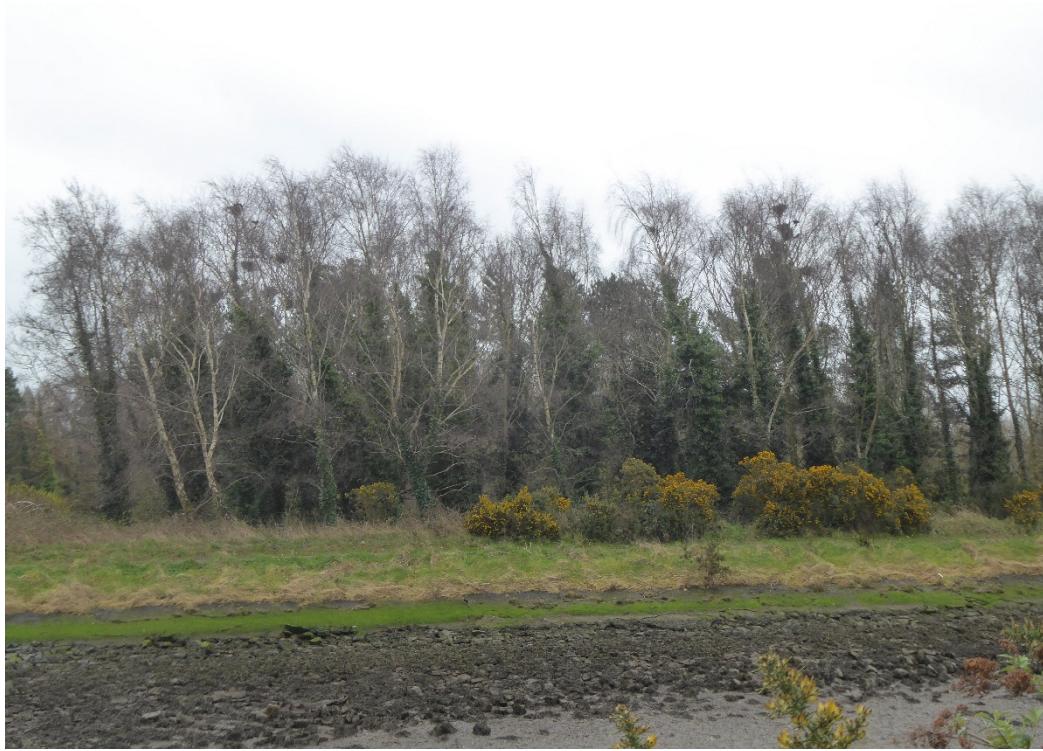
Rookery showing habitat type (ivy clad oak/birch with pines behind)

Remedial action in the first instance would involve the removal of old nests – outside of the breeding season - to prevent them advertising the suitability of the site to new prospecting pairs. As site fidelity after only one year might still be strong, any signs of rebuilding would need to be discouraged until the habitat can be modified to the extent that rooks no longer find it attractive. Such management prescriptions would include thinning of sheltering pines, strategic structural pruning of preferred nesting trees, and reducing shelter from high level ivy.
